SUBJECT: Research Report; Final Evaluation of Grooved Centerlines;
I-71- 2(15)37; HPR - 1(6), Part III, KYP - 18; Experimental.

Research Report
314

**GROOVING PAVEMENT CENTERLINES
FOR LANE DEMARCATION**

Final Performance Report
KYP 18

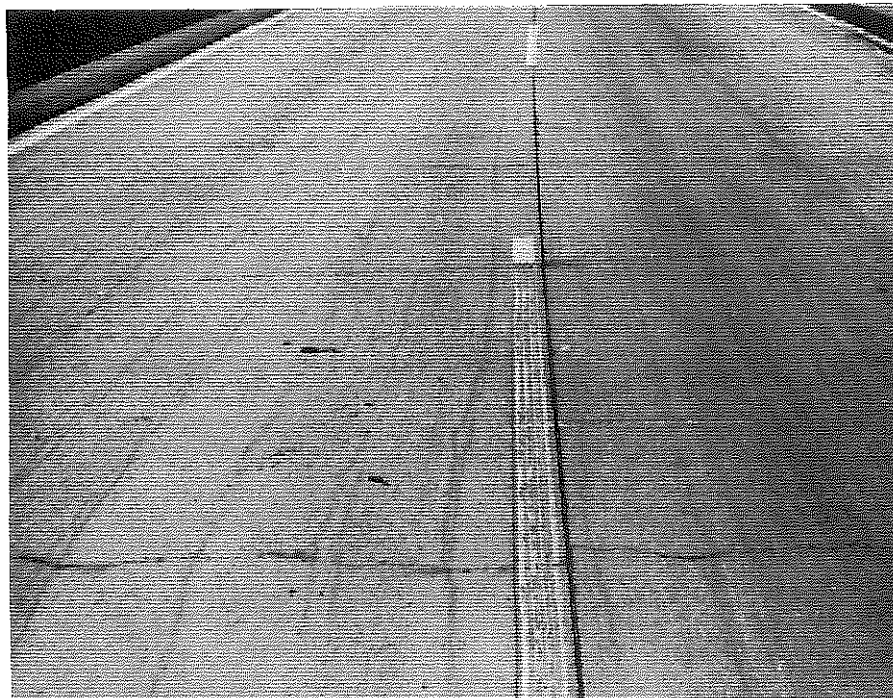
During the early summer of 1971, a year after the first repainting, the stripes were again inspected. In general, the grooved stripes showed much more wear and (or) loss of paint than the ungrooved stripes (Figures 1, 2, and 3). Therefore, during dry, daytime and wet, daytime conditions, the grooved stripes were less visible

Figure 1. Differences in Wear between Grooved and Ungrooved Stripes. Notice overlap of paint onto ungrooved surface. (June 1971)

than the ungrooved stripes. Intensified wear and (or) chipping caused premature loss of paint on the ridges (lands). Figure 1 shows paint lapped onto an ungrooved surface and an ungrooved line in the background (see Figure 5 also).

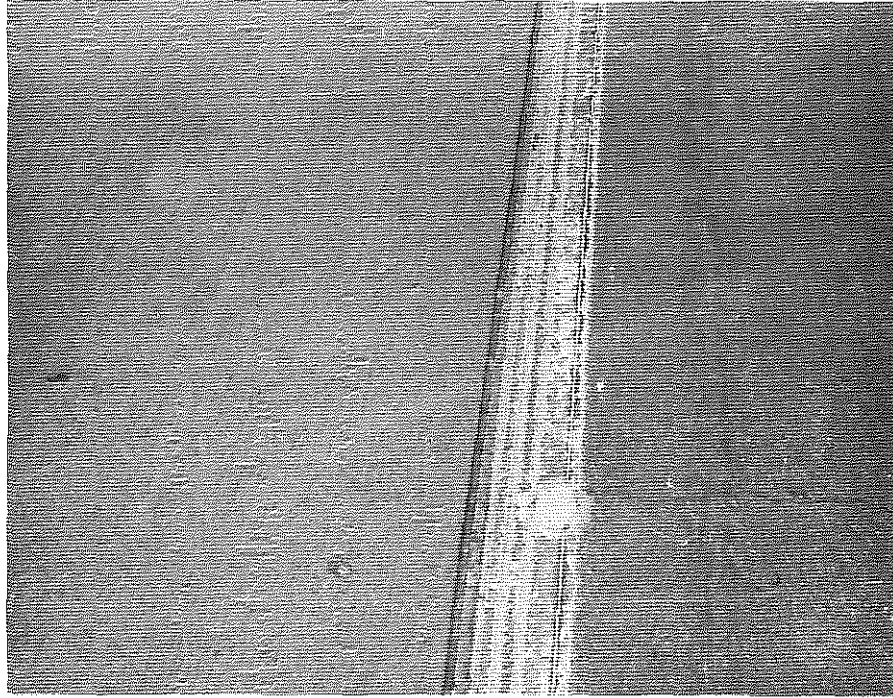
**Figure 2. Loss of Paint from Grooved Centerline
One Year after Repainting. (June 1971)**

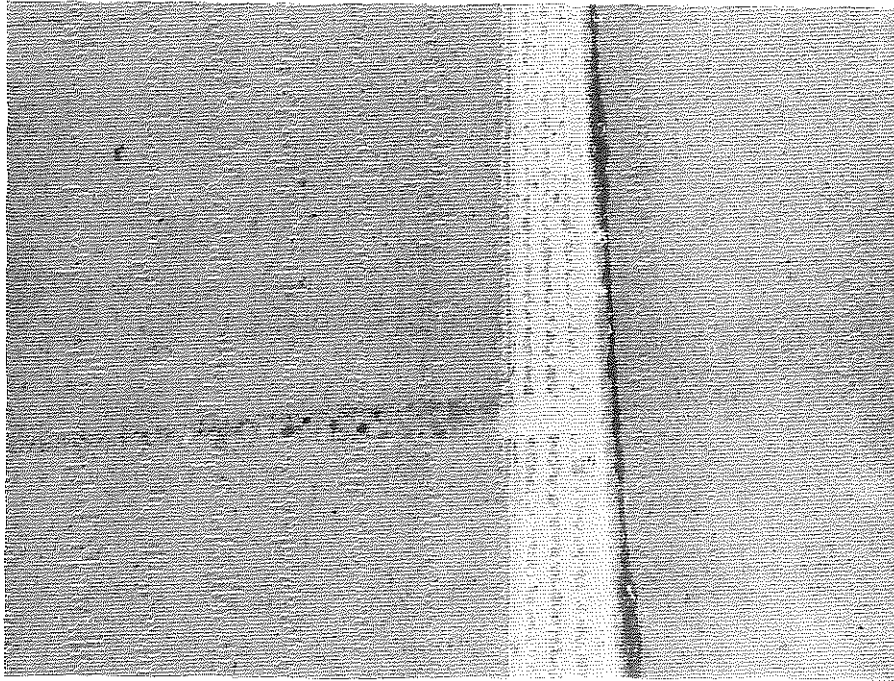
Figure 3. Loss of Paint Is Most Significant on Ridges (Lands) of Grooved Centerline. (June 1971)

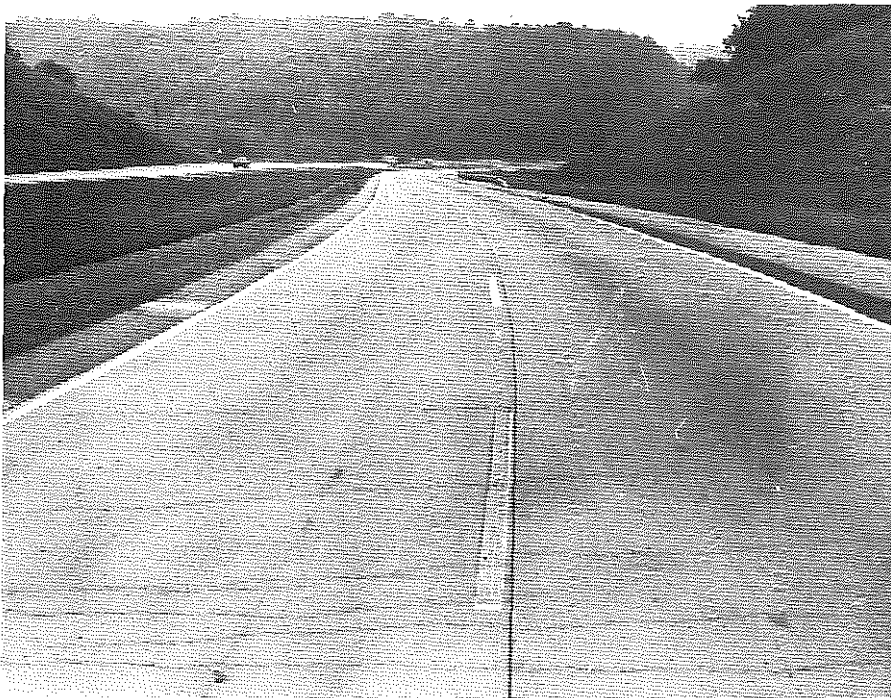
Figure 4. Appearance of Centerlines during Dry, Daytime Conditions One Year after Repainting. (June 1971)

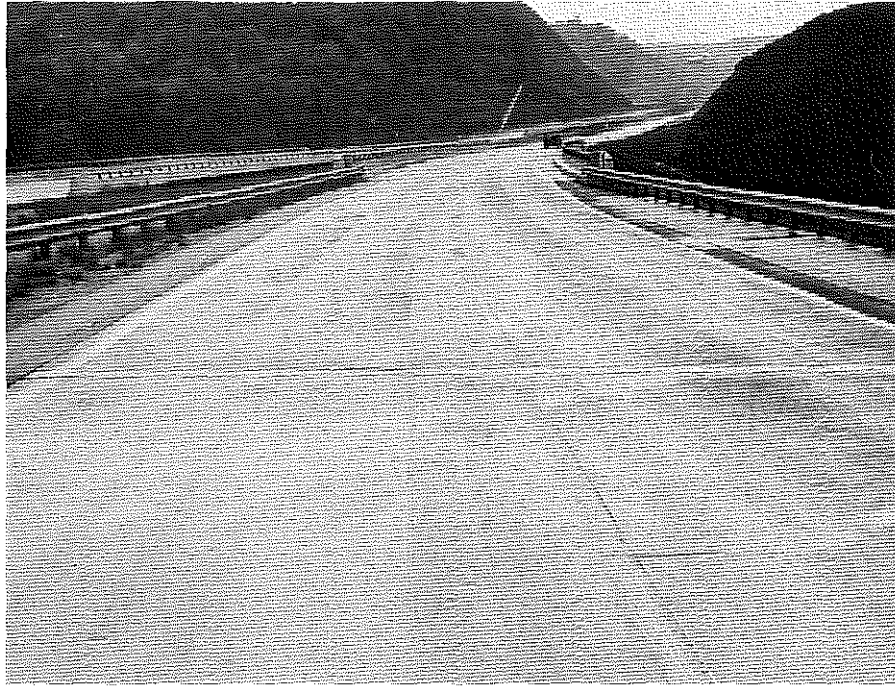
**Figure 5. Appearance of Centerlines during Wet,
Daytime Conditions. (June 1971)**

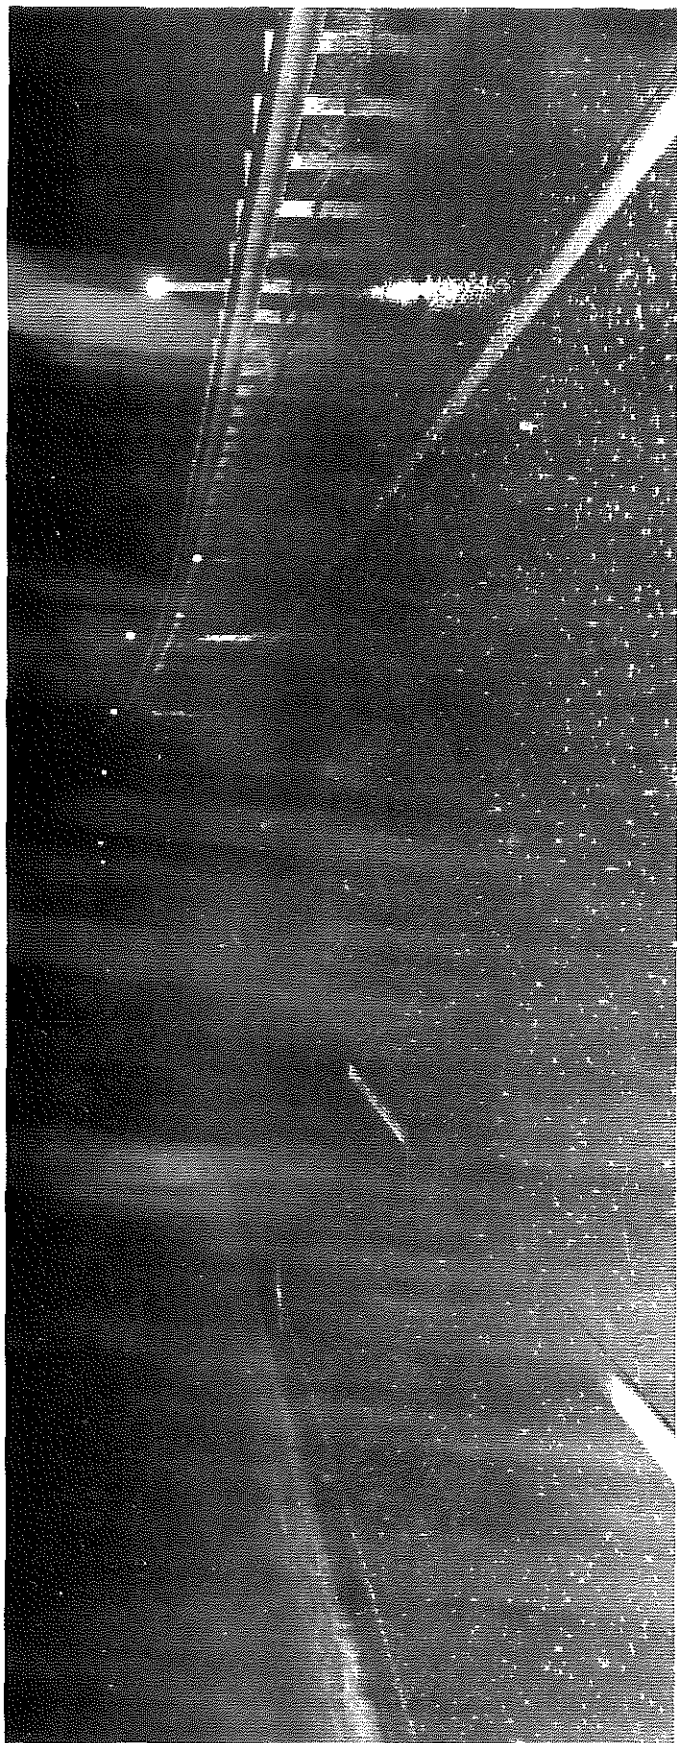
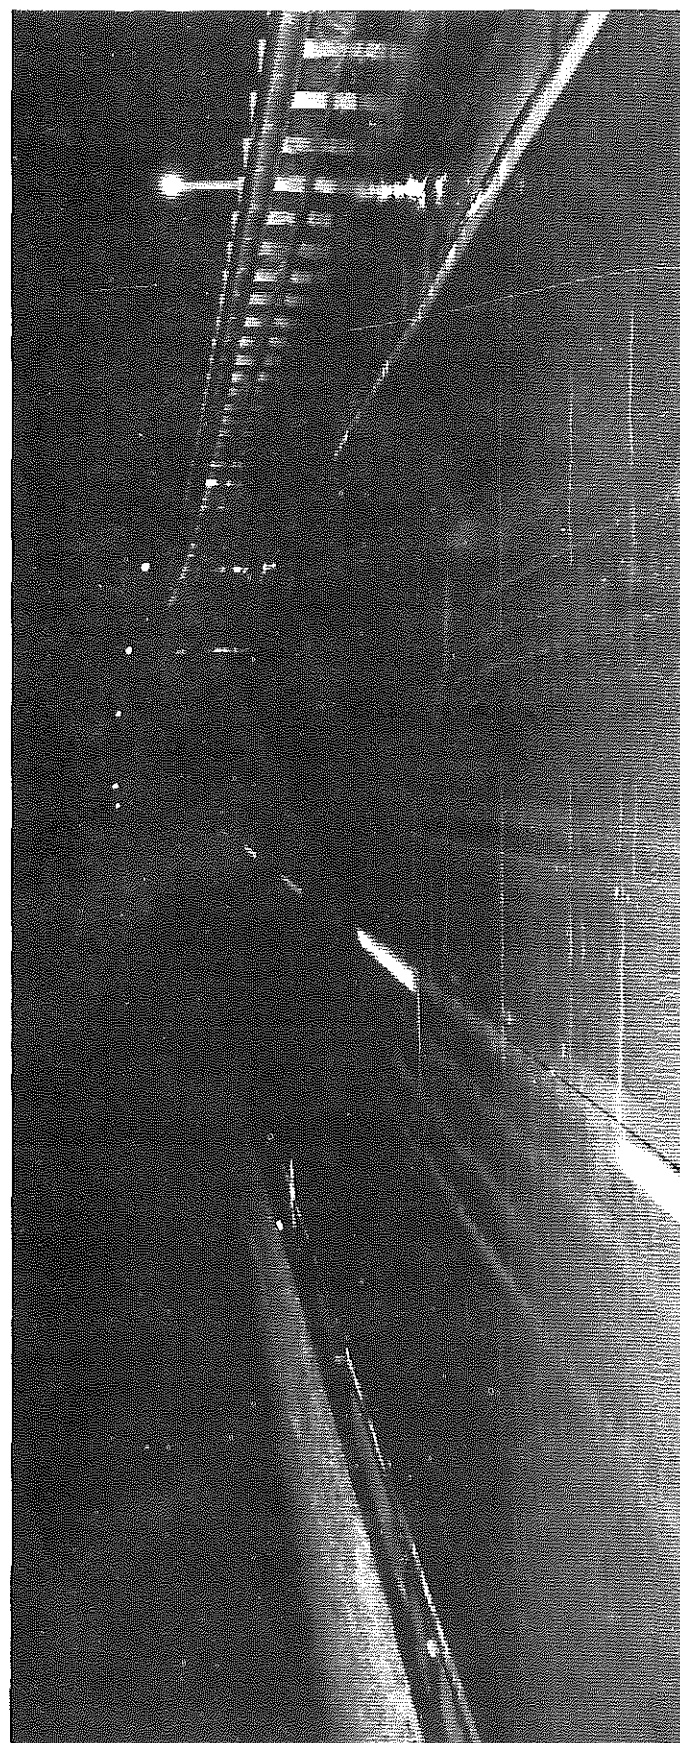
The project was restriped again in July 1971. Several attempts have been made to obtain high-quality photos of lines during rainy night conditions. Figure 6 was obtained in October 1971.

Figure 6. Appearance of Lines during Rainy, Nighttime Conditions after Second Repainting. (October 1971)
